Using greenery to cool a residential area Merelbeke Tuinwijk Jan Verhaegen

Summary (max 100 words)

- Redundant connecting roads and concrete areas converted into attractive small green park with playground and wadi in the heart of a residential neighbourhood
- Contributes to neighbourhood climate resilience by reducing heat stress and water runoff, whilst also enhancing social cohesion, maintaining good access and improving neighbourhood appearance and real estate value.

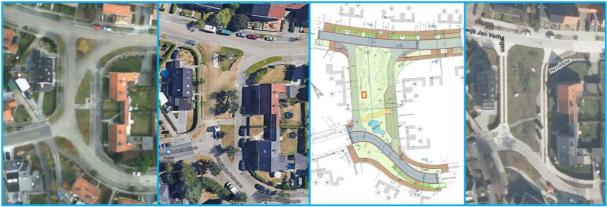
Figure 1: Leftmost: original situation of central connecting roads. Left-centre: temporary "test"installation. Centre right: final design. Rightmost: aerial photo after completion construction works, before finalising planting.

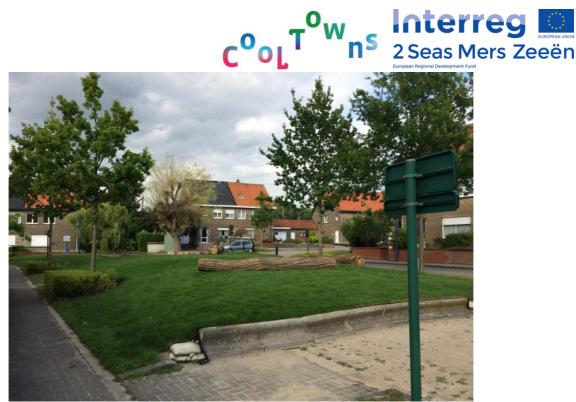
Figure 2: temporary measure: a temporary "test" park was placed on top of the concrete roads. This way neighbours could get used to the general idea, understand what was envisioned, and feedback could be gathered without excessive costs.

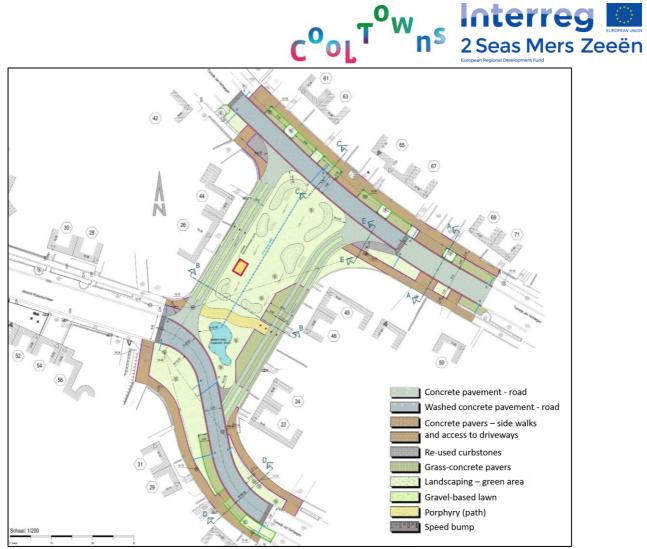
Figure 3: Final design for central area in Tuinwijk Jan Verhaegen. Sandbox was not implemented.

- Removal of 1000m² paved surface and replacing this with open ground
- The remaining paving was removed and replaced by:
 - Parallel concrete wheel guides for cars, with gravel-based grass in between and turning areas enforced with grass-concrete permeable paving
 - Paved parking lanes were either removed or replaced by water-permeable grassconcrete pavers
 - Concrete replaced by grass lawn with sustainable drainage system (wadi) to catch runoff water from the park and allow it to infiltrate into the ground.
 - Access for emergency vehicles was guaranteed by including a turning area constructed from recycled kerbstones.
- Trees and shrubs were added to the park, with additional trees with an understorey of shrubs added in beds along the main road.
